DEFENDANTS' EXPERT WITNESS DISCLOSURES

Donan Engineering was retained to conduct an inspection and create a written report of its findings regarding alleged hail and wind damage at Plaintiff J&S Welding, Inc.'s ("J&S Welding") property located at 2579 North 9th Avenue, Humboldt, Tennessee 38343 (the "Property").

OCTOBER 6, 2021

Burr Forman Claim No: 23930877
Envista Matter No: MAT-141908-G4Z7
REPORT DATE: January 6, 2023

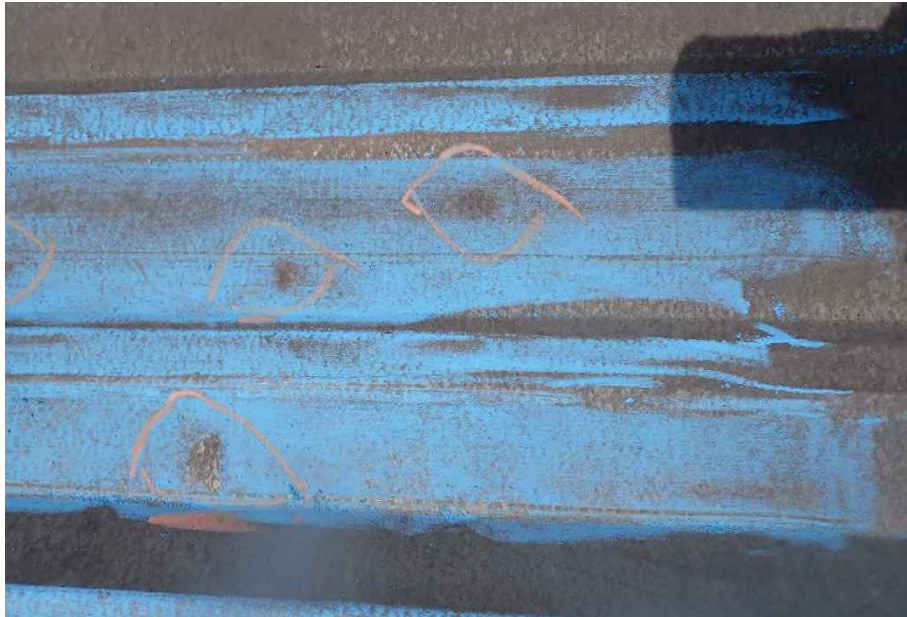
Photograph 21.

View of roughly circular indentations in the roof covering.

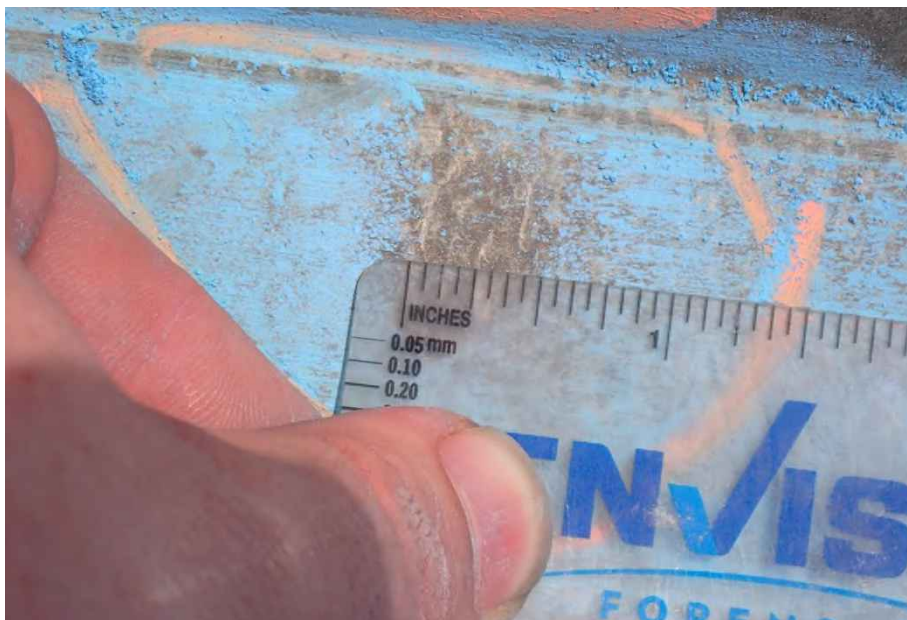
Photograph 22.

View of roughly circular indentations in the roof covering.

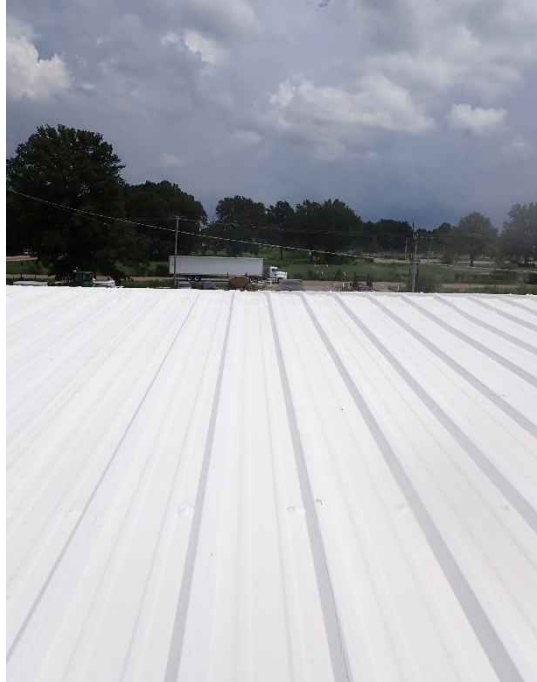
Photograph 23.

View of white coating on approximately half of the north roof covering for building #1.

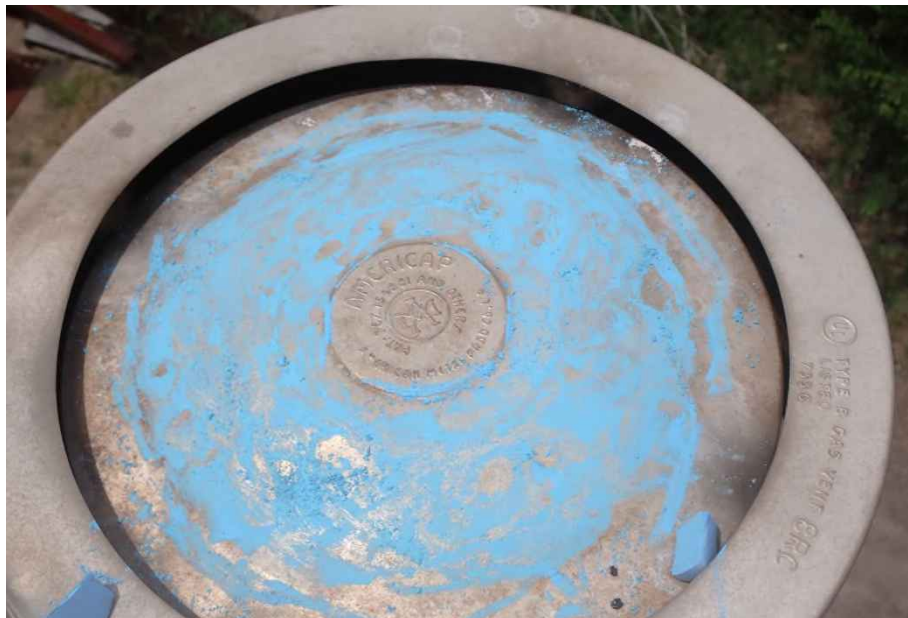
Photograph 24.

View of roughly circular indentations in gas vent cap.

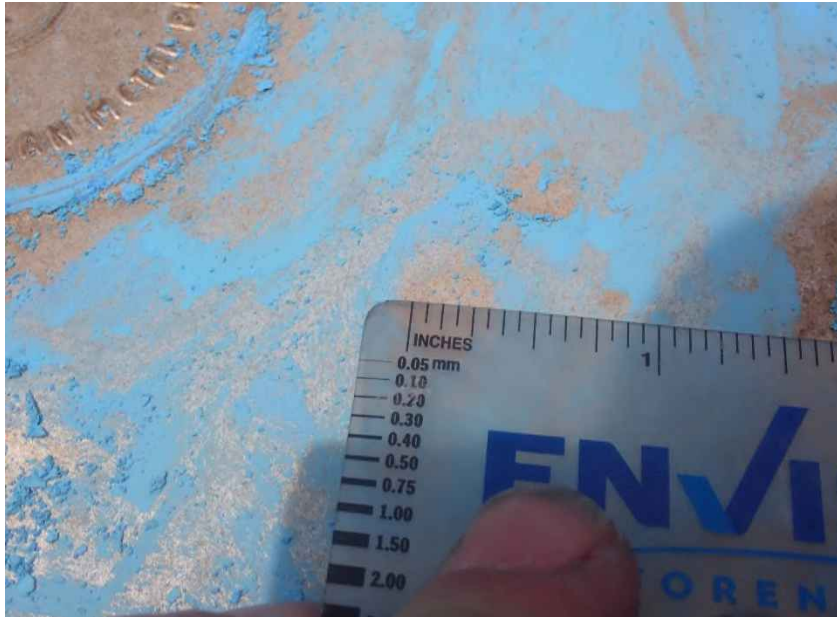
Photograph 25.

View of roughly circular indentations in gas vent cap.

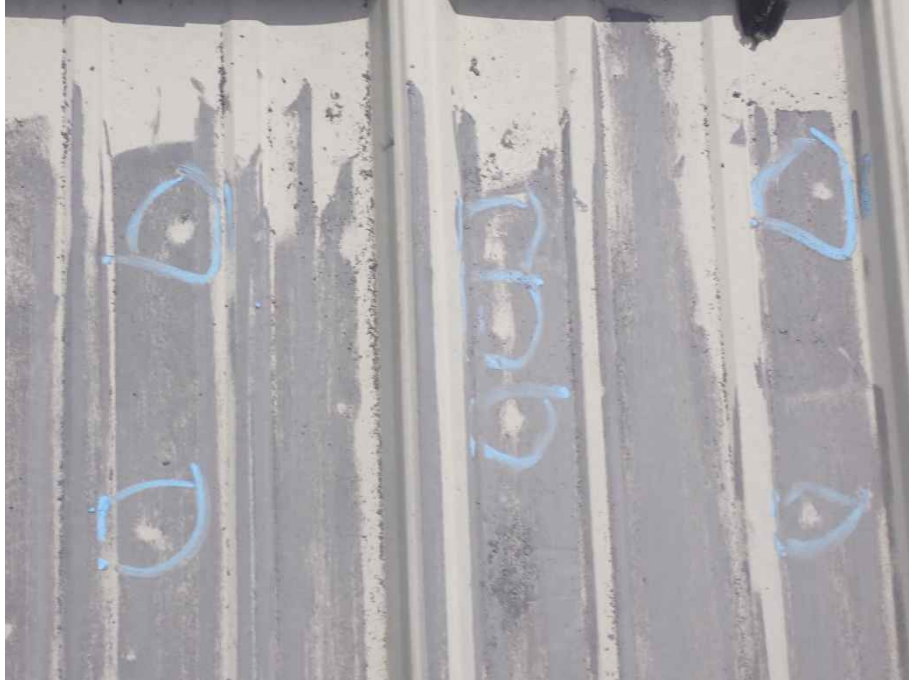
Photograph 27.

View of roughly circular indentations in metal roof covering for building #2.

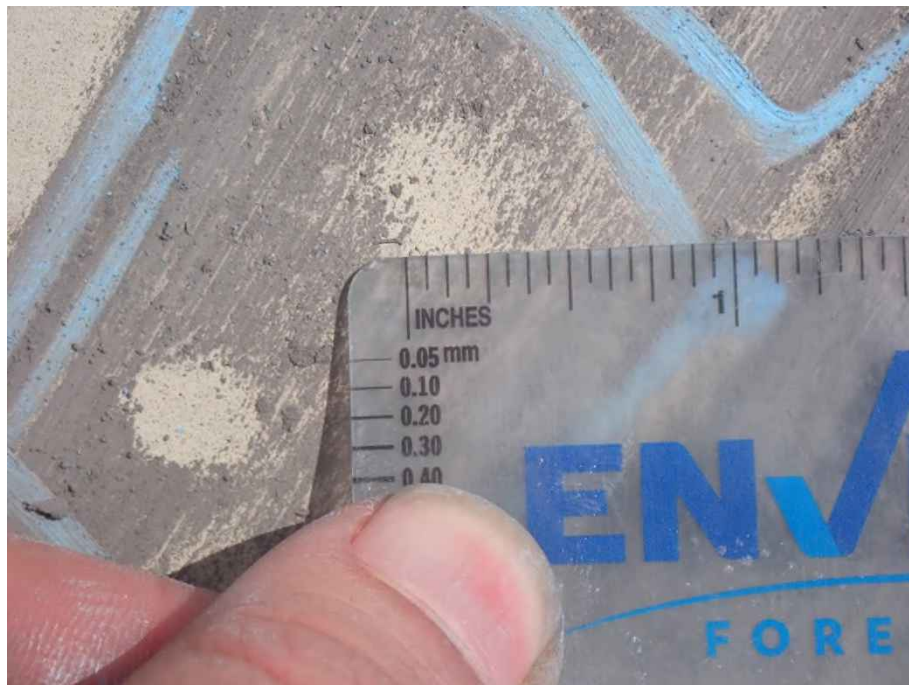
Photograph 28.

View of roughly circular indentations in metal roof covering for building #2.

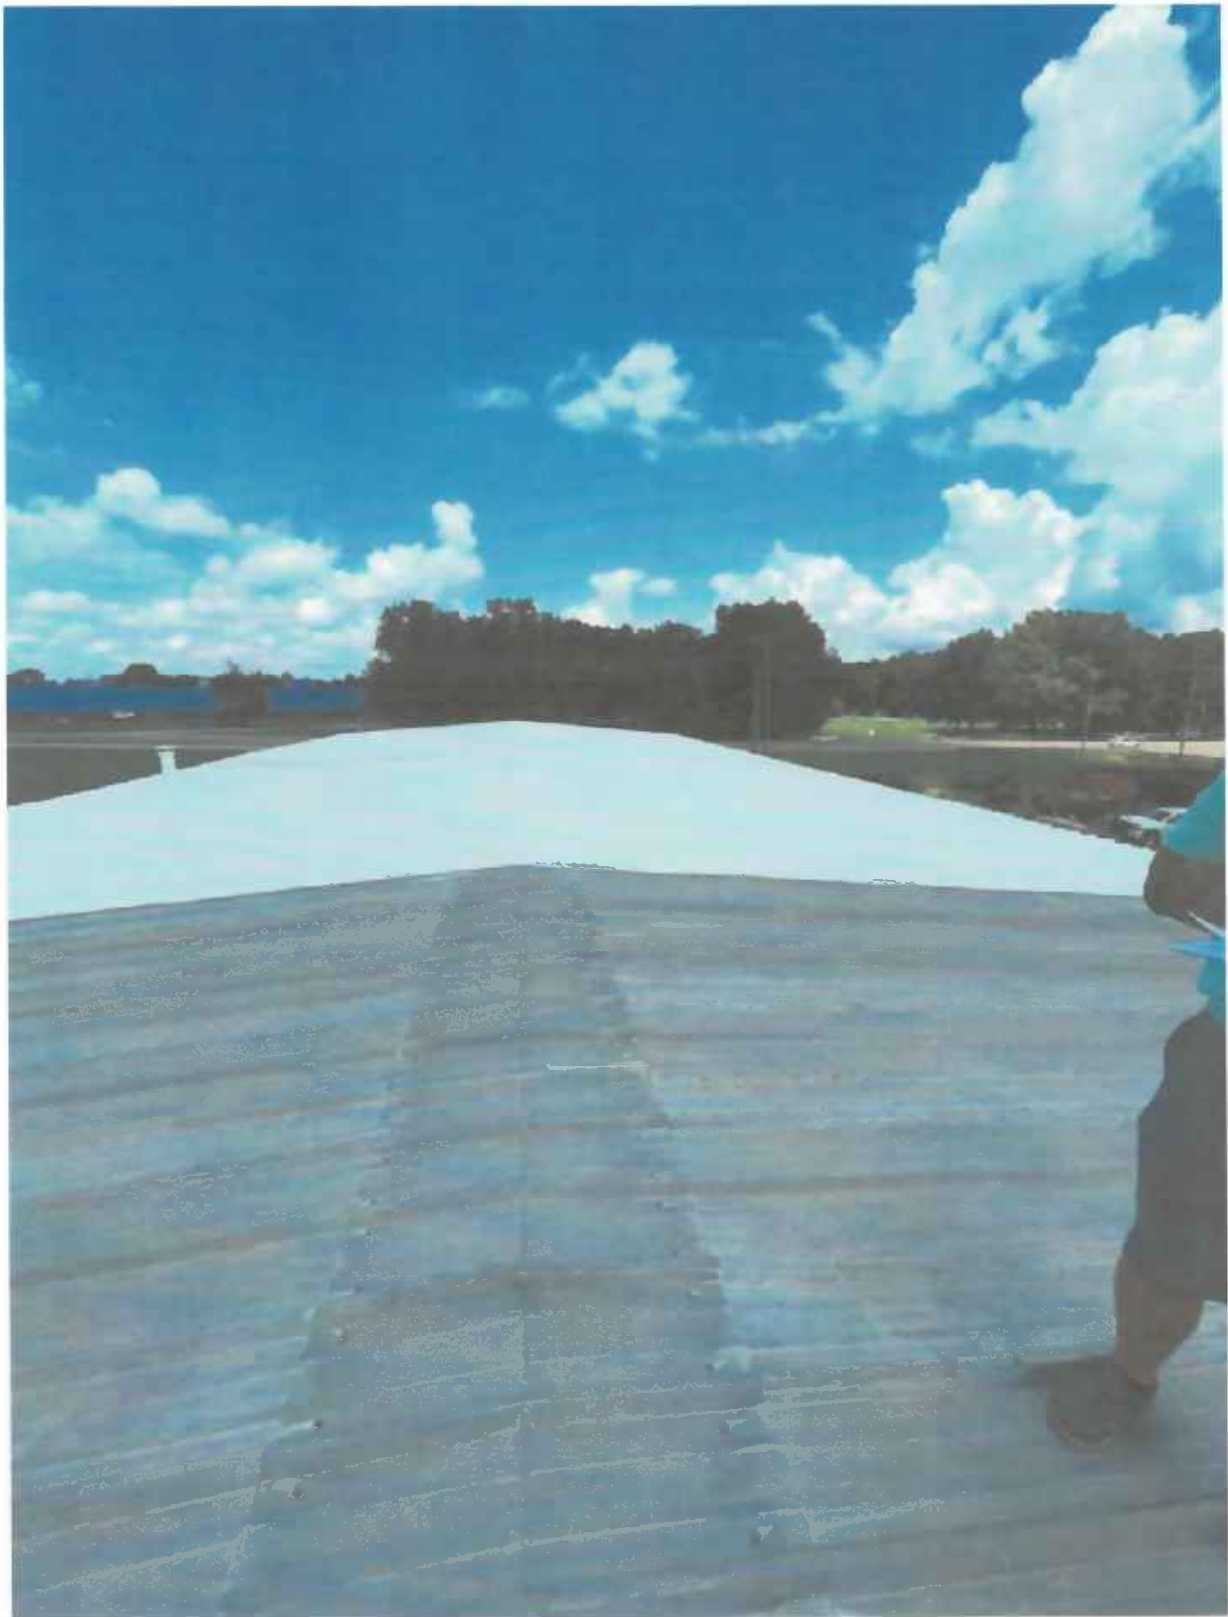
The roof of the building one is a commercial PBR metal panel. These panels are typically around 24 gauge. A portion of the building has had a sealer applied to the metal panels. This sealant prohibits my ability to properly inspect the metal panels. The portion of the building without sealer is owned by someone else beside J&S Welding. Even though the sealer has

been applied, the unsealed panels look similar. The following photo shows the sealer.

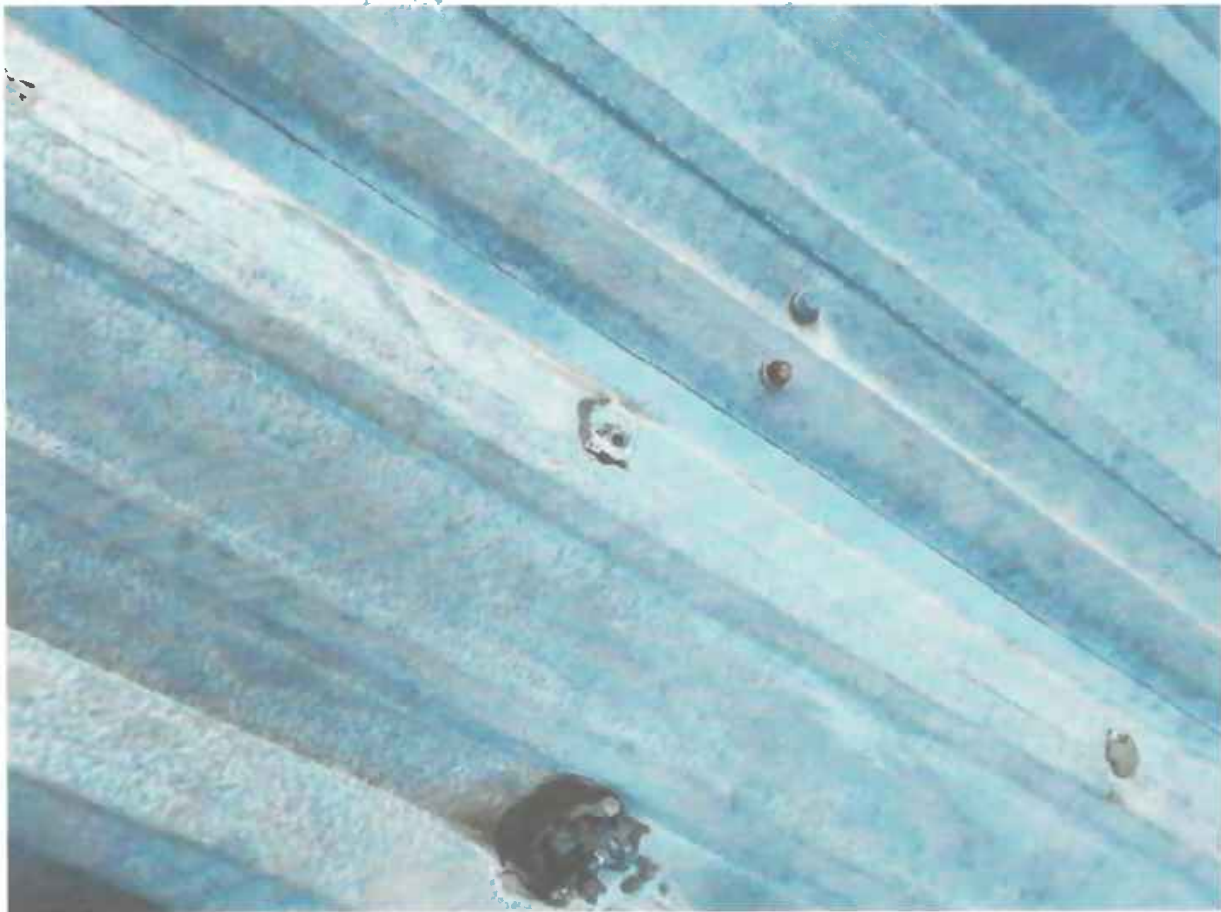
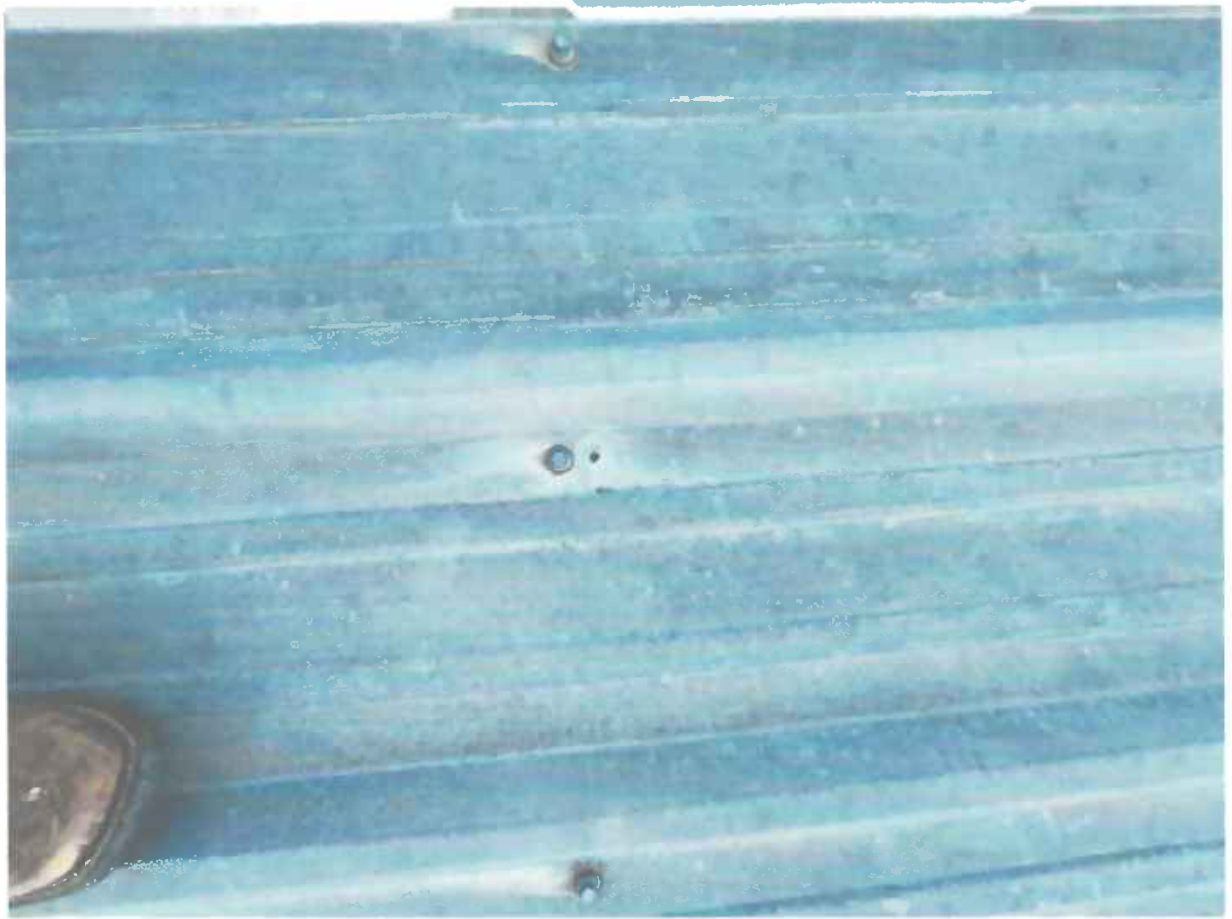
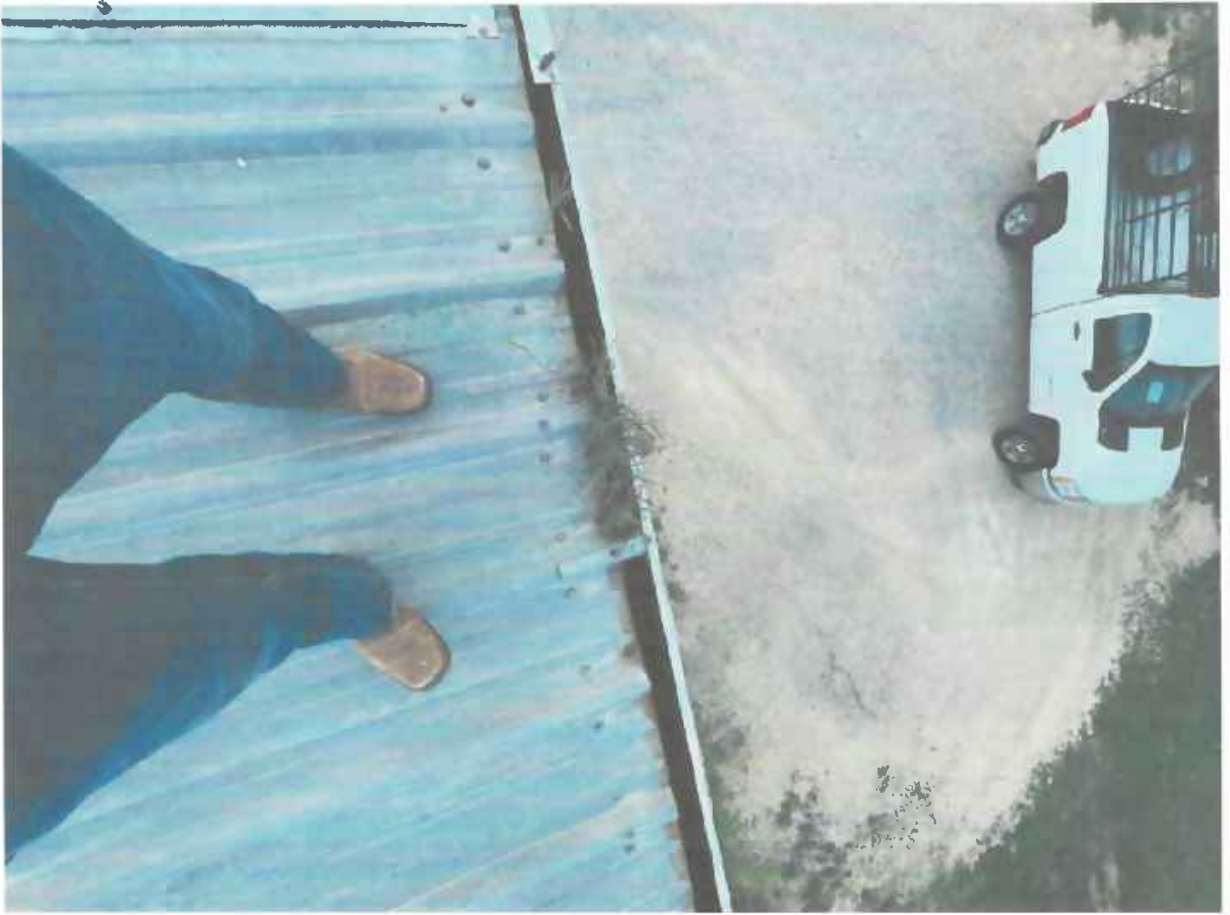
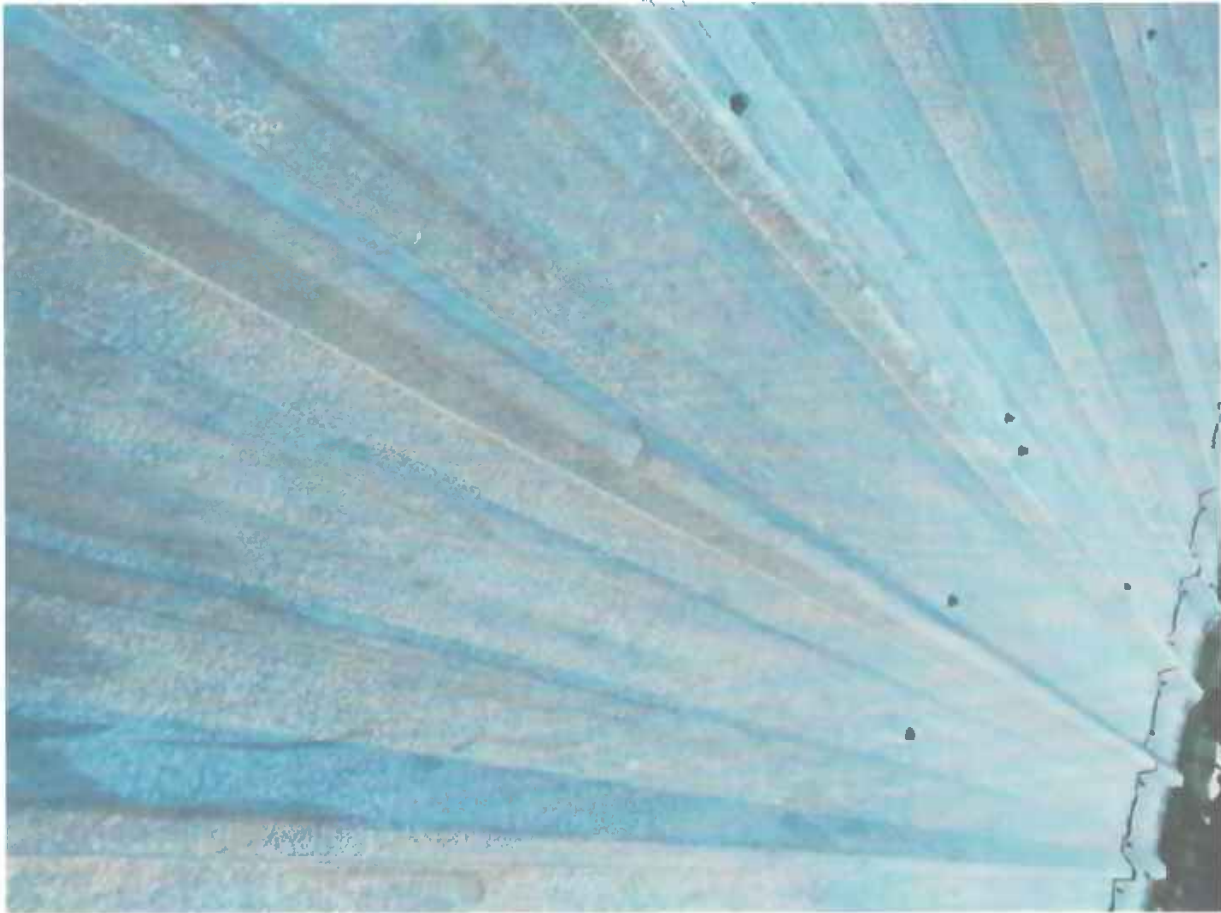
The portion of the building without sealer has multiple issues. These issues are a result of deferring maintenance. The roof has multiple locations with screws missing that leave holes through the metal roofing exposed that will cause leaks. It has multiple places that gutters need to be cleaned out to the point that weeds/grass have started to grow. If gutters do not drain properly it can cause water to back up and leak into the interior space. The following pictures show some of the issues. Building one also has some ribs located on the metal panels that have been creased or bent. The ribs of the metal panels are the portion of the panel that extends upwards from the roof deck. The bent ribs do not appear to be a result of hail damage. The creases are more of a straight line. These typically happen during manufacturing, installation or from the roof being walked on. Some of the creases appear to have been welded at some point or had a sealer put on them.

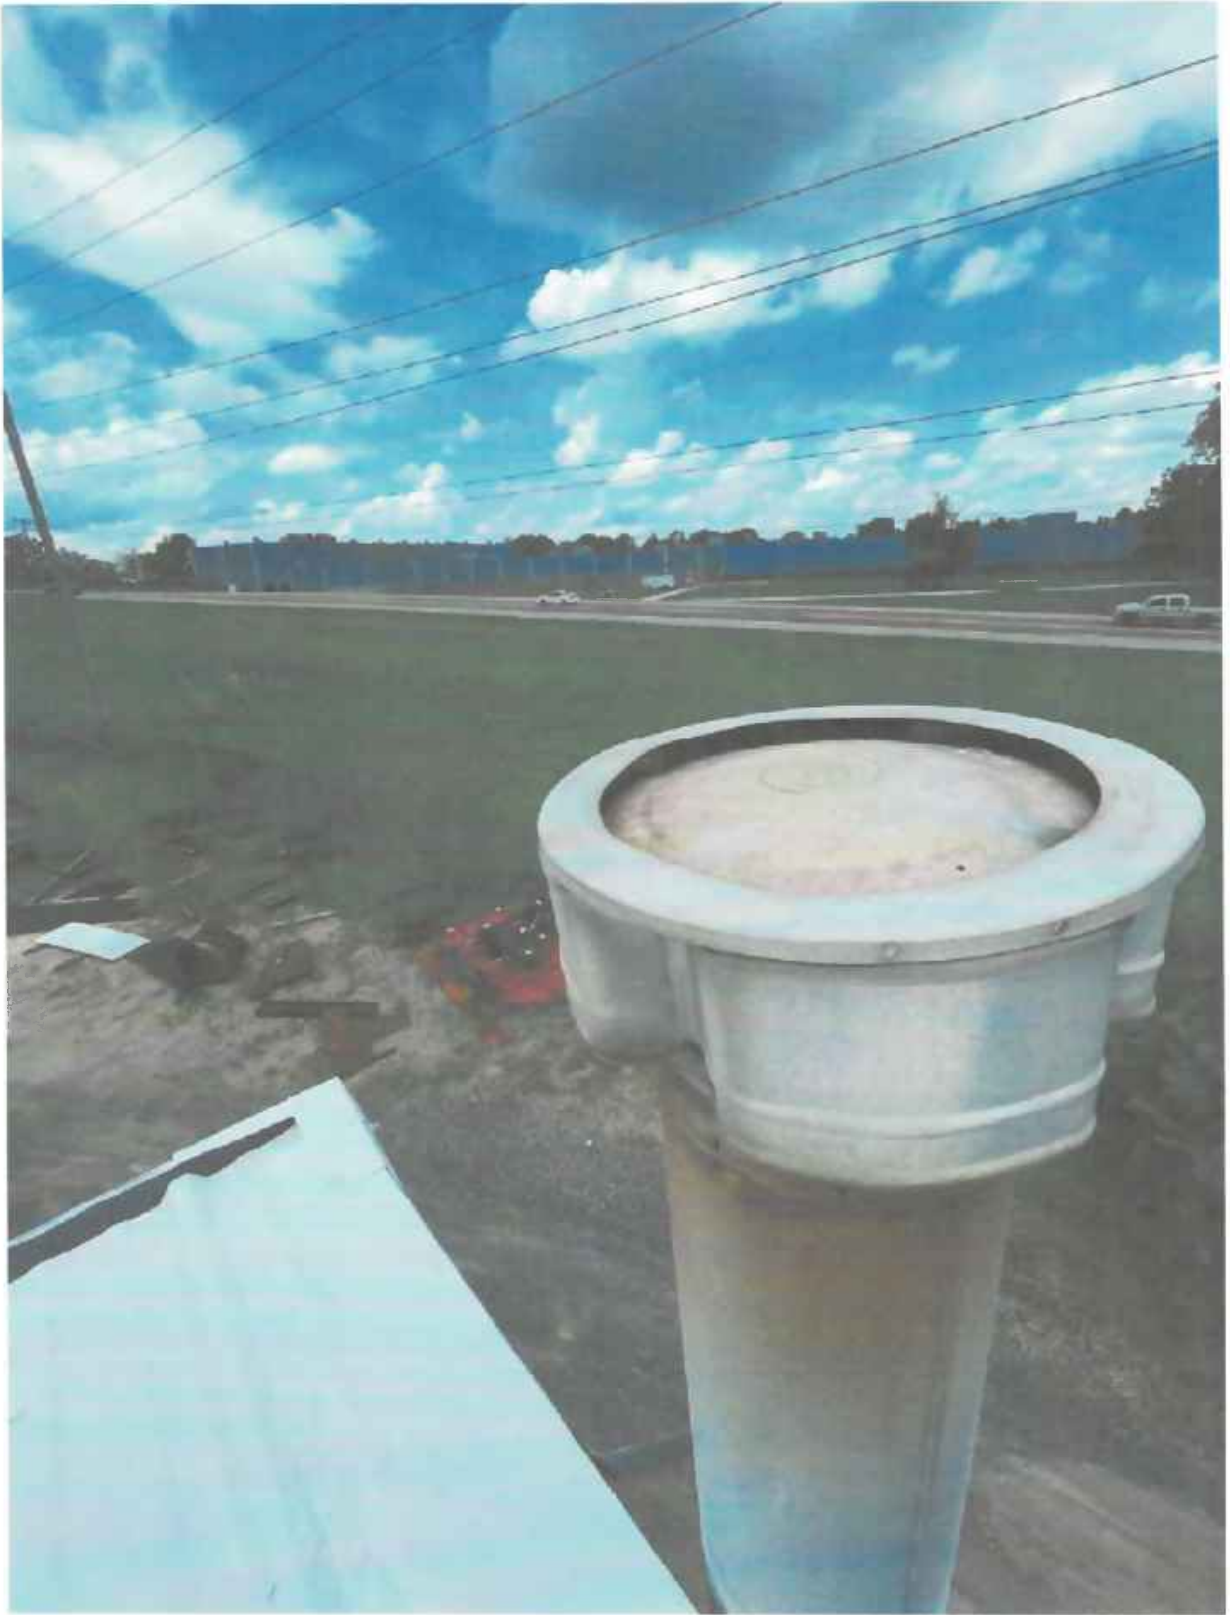
Hail damage to the roof was observed but so minor in nature that it does not appear in photos nor would it effect the functionality of the roof. It is my opinion that any leaks on the roof of the main building would be caused by maintenance issues and not hail damage. The soft metal aluminum vents show very minor hail damage. Typically with these being a softer metal they show more damage than the steel roofing. The vent is shown in the following photo.

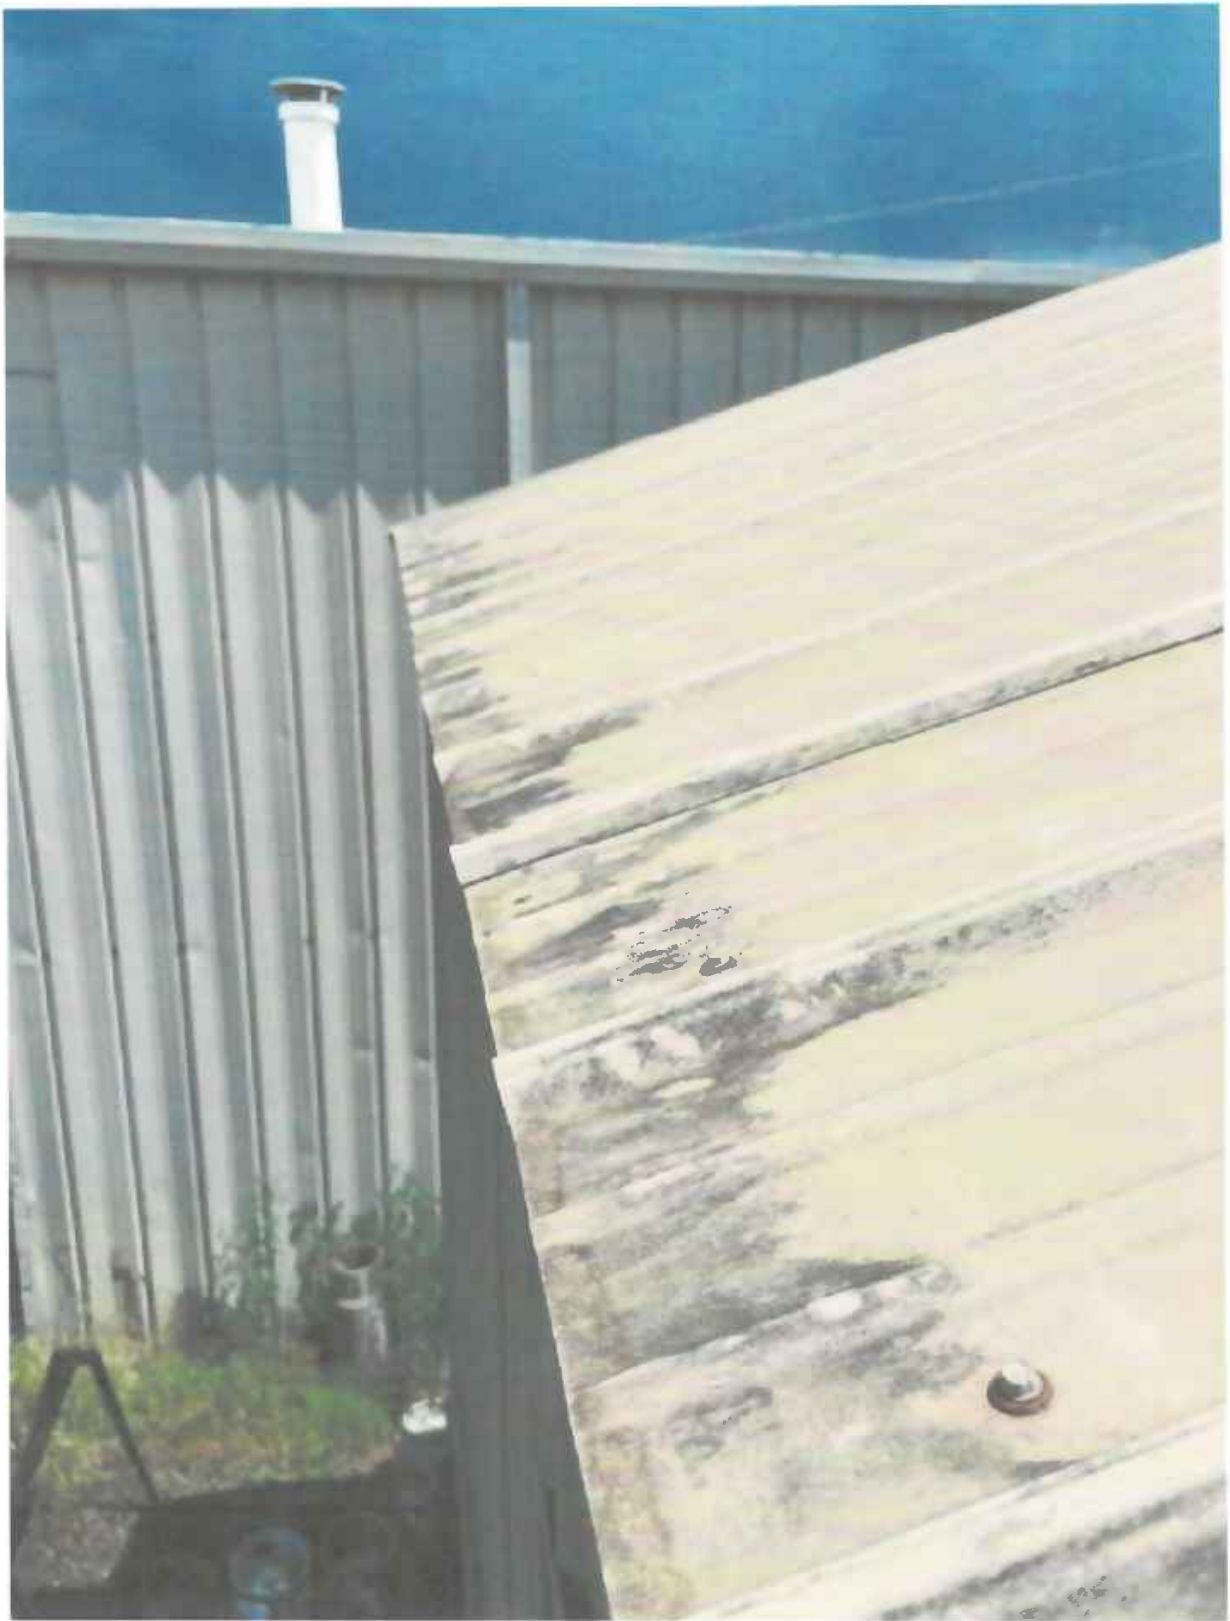
Building two has a different metal panel. The type of metal panel on building two is typically around 29 gauge. It was easier to see hail damage on the roof of building two but again no hail damage was observed that would affect the functionality of the roof. Building two was free of the maintenance issues observed on building one. The following photo shows hail strikes on Building two.

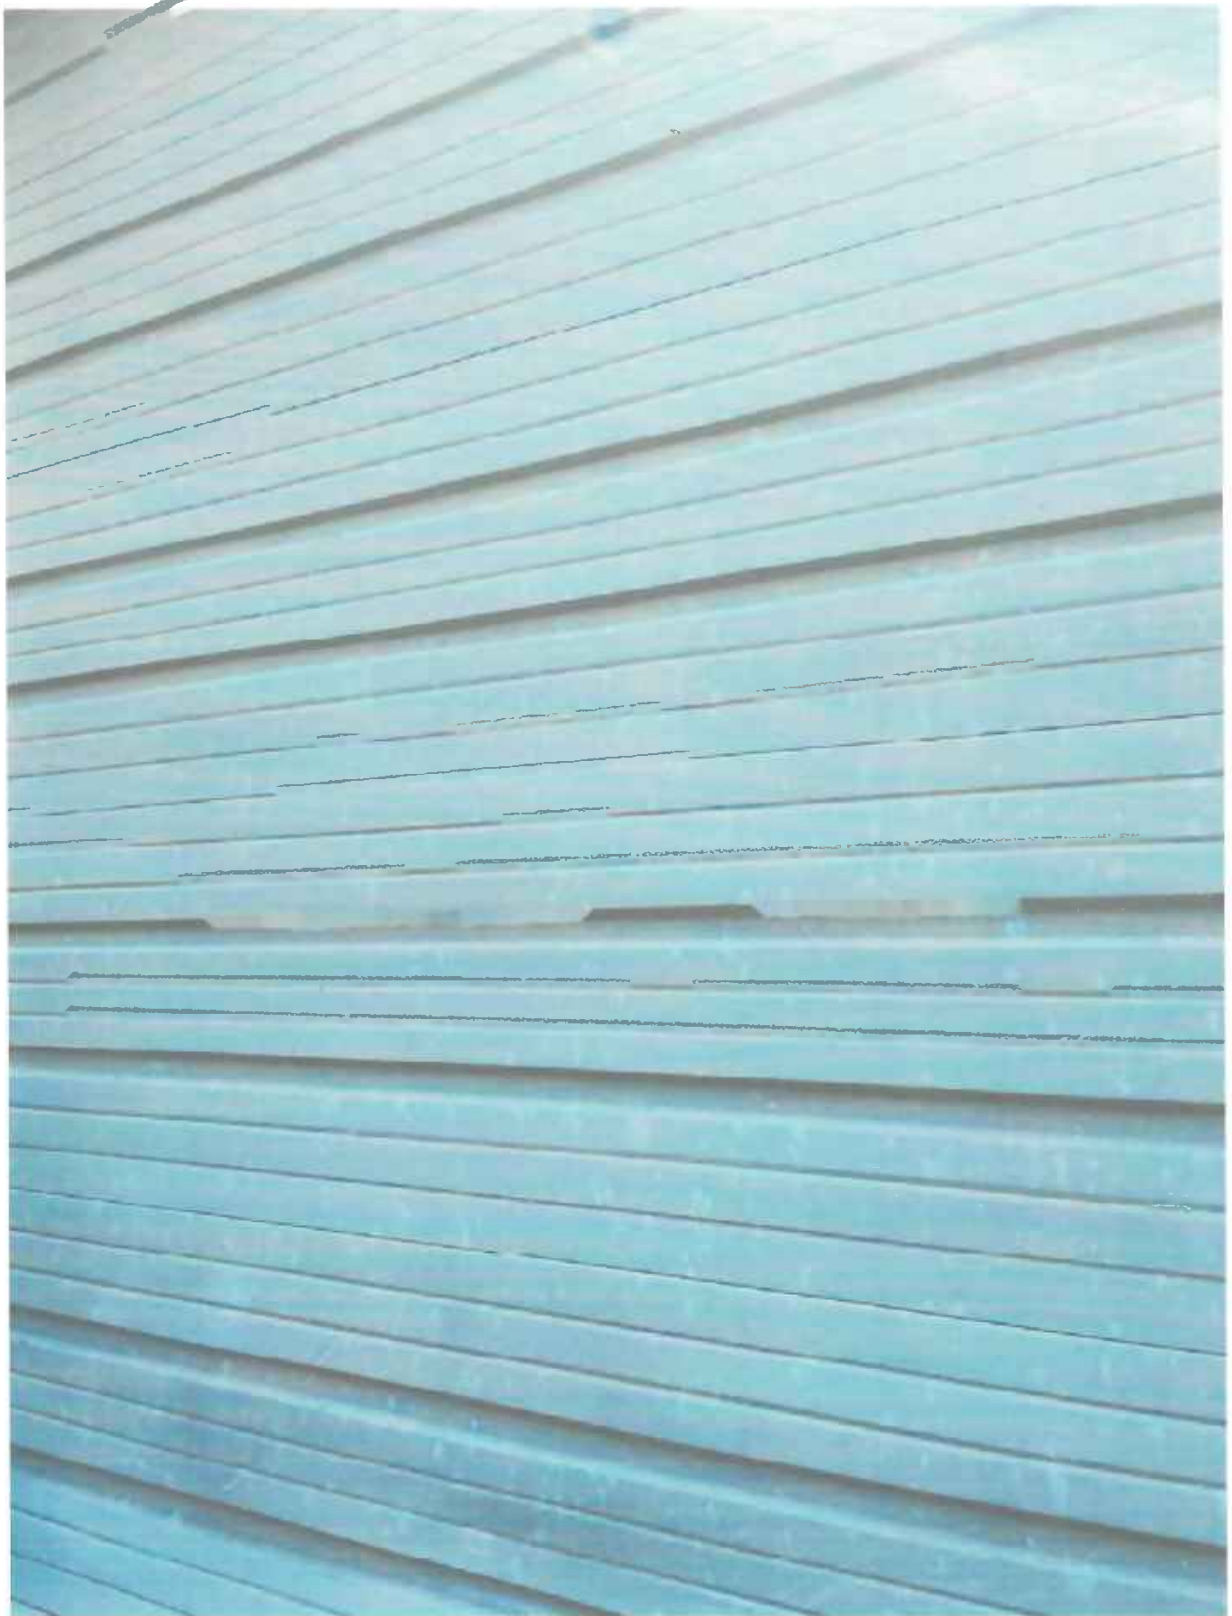
Both building one and two have a similar metal panel on the walls. Both buildings have hail damage to the trim metal, garage doors and metal wall panels. The garage door of building two is the worst I observed on the day of my inspection. It is shown in the following photo.
